**National Highway
Traffic Safety
Administration**

CALSPAN ON-SITE AIR BAG DEPLOYMENT INVESTIGATION

CALSPAN CASE NO. 91-08

VEHICLE - 1991 FORD TAURUS

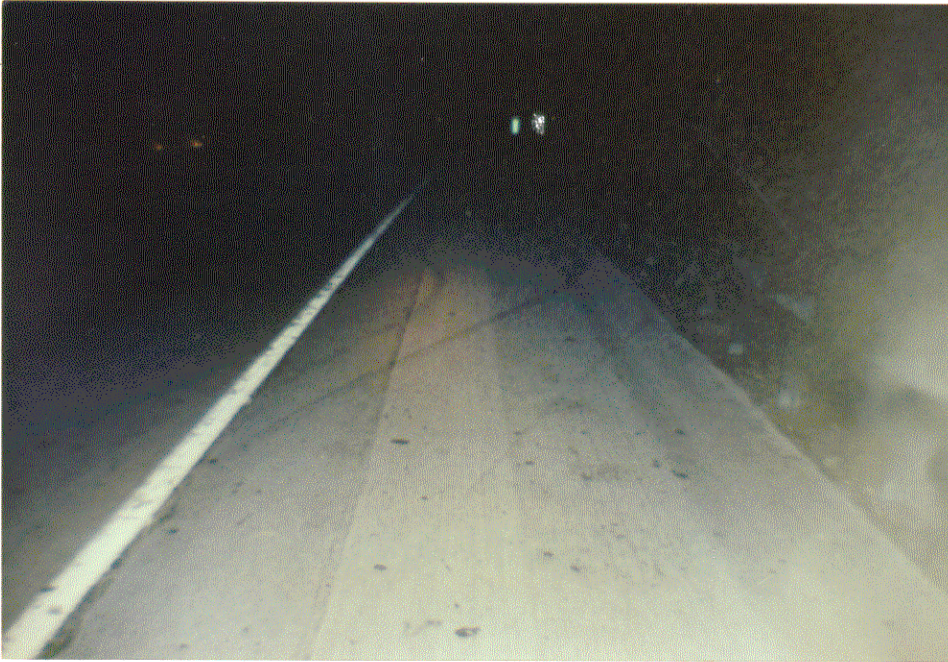
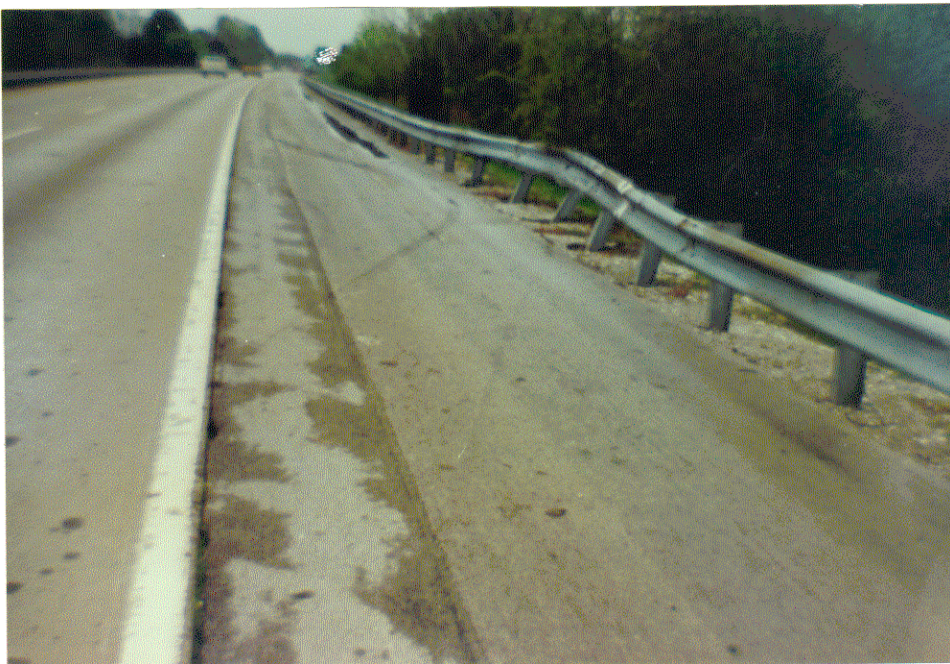
Pre-Crash Clockwise Yaw Marks From The Ford Taurus.

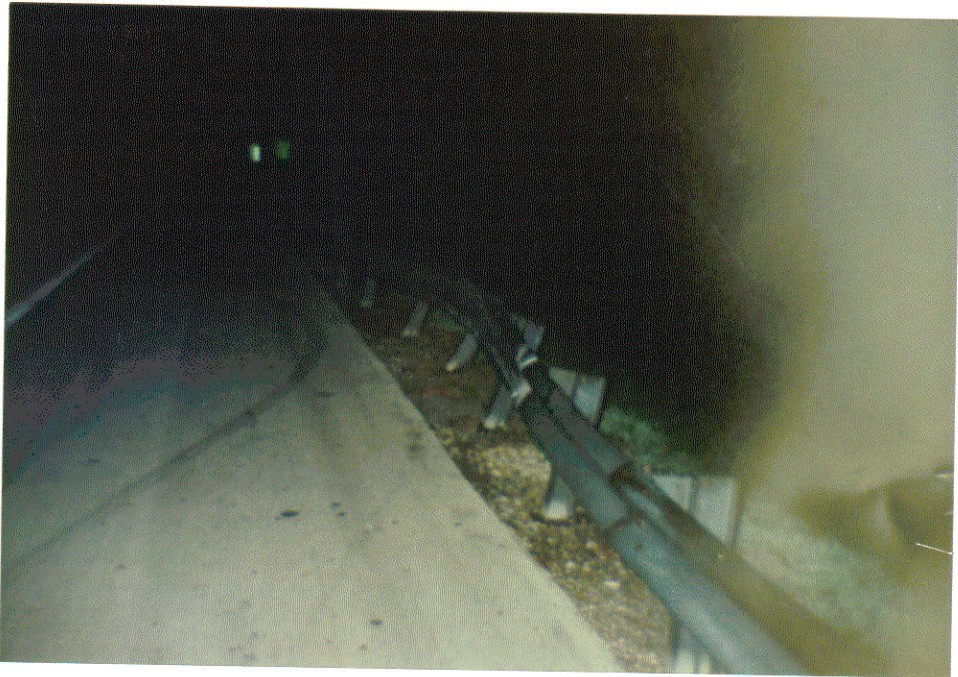
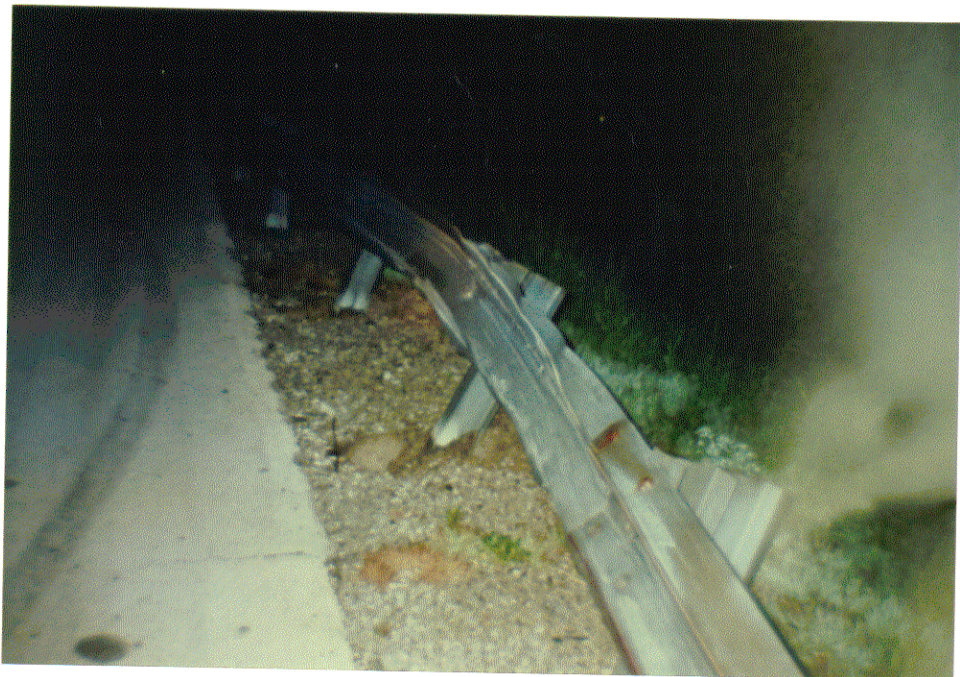
Deployment Impact Sequence With The W-Beam Guardrail.

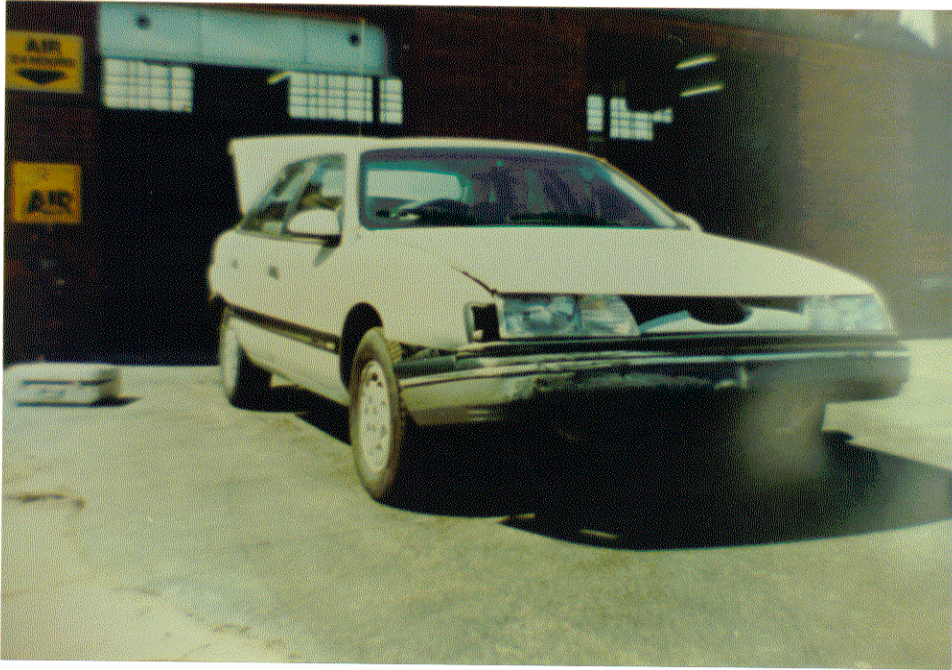
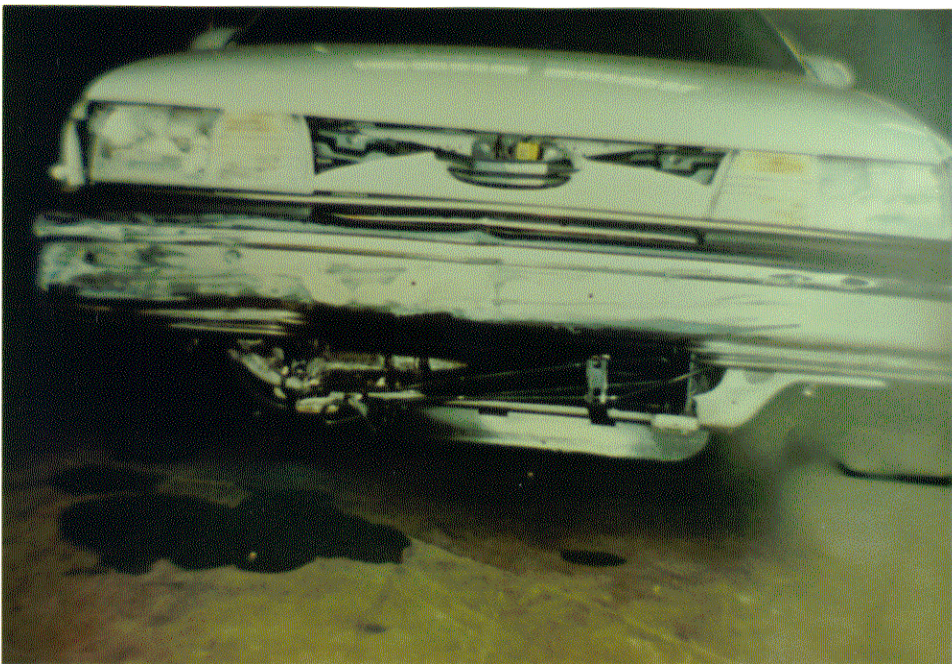
Primary - The frontal area of the Ford Taurus impacted a W-beam guardrail which resulted in minor damage to the bumper and adjacent components. Maximum crush was 2.0" that was located at the right corner of the bumper. Direct contact damage on the bumper face began 22" left of the vehicle's center line and extended 52.4" to the right corner. The impact compressed both bumper energy absorbing devices (EADs) which resulted in a combined induced and direct contact damage length of 60.25" that involved the entire bumper. The left bumper EAD compressed 0.4" while the right unit compressed 1.6". Both EADs returned to their original pre-crash positions. Crush values were measured at six equally spaced increments across the front bumper and were as follows:
C₁=0", C₂=0", C₃=0", C₄=0.1", C₅=1.0", C₆=2.0".

Frontal Damage To The Ford Taurus.

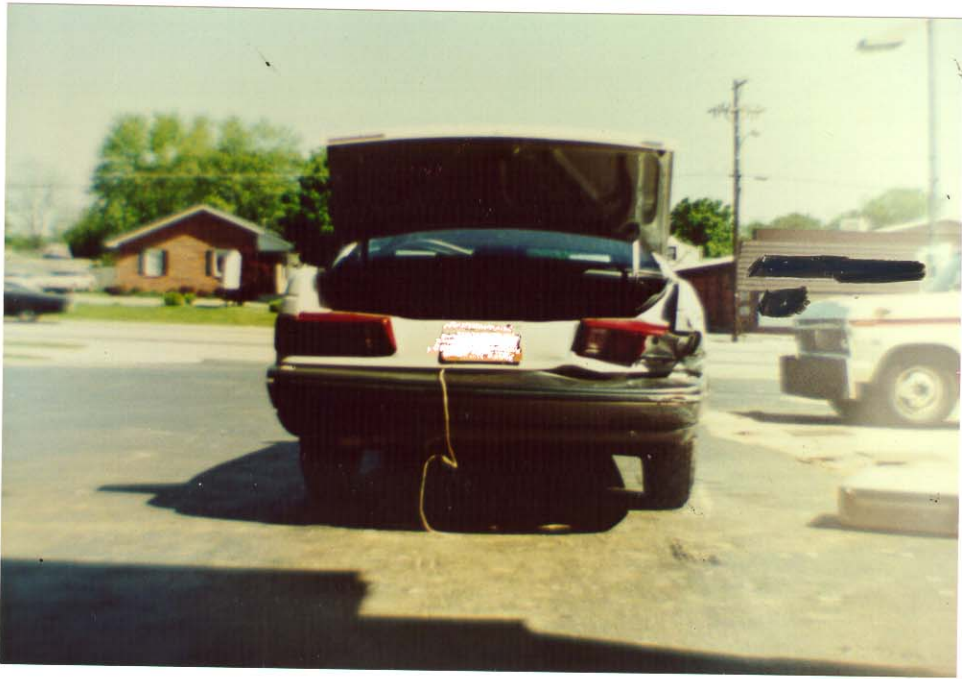
Secondary - The right rear area of the Ford Taurus impacted the median W-beam guardrail as the vehicle rotated across the travel lanes. Direct contact damage on the rear bumper began 17.5" right of center and extended 12.6" to the right rear corner area. Although no residual bumper crush occurred (no EAD compression) as a result of the impact, the right taillamp area of the vehicle engaged with the guardrail resulting in 4" of sheetmetal crush at the right rear corner.

Secondary Guardrail Damage To The Right Rear Corner Area.

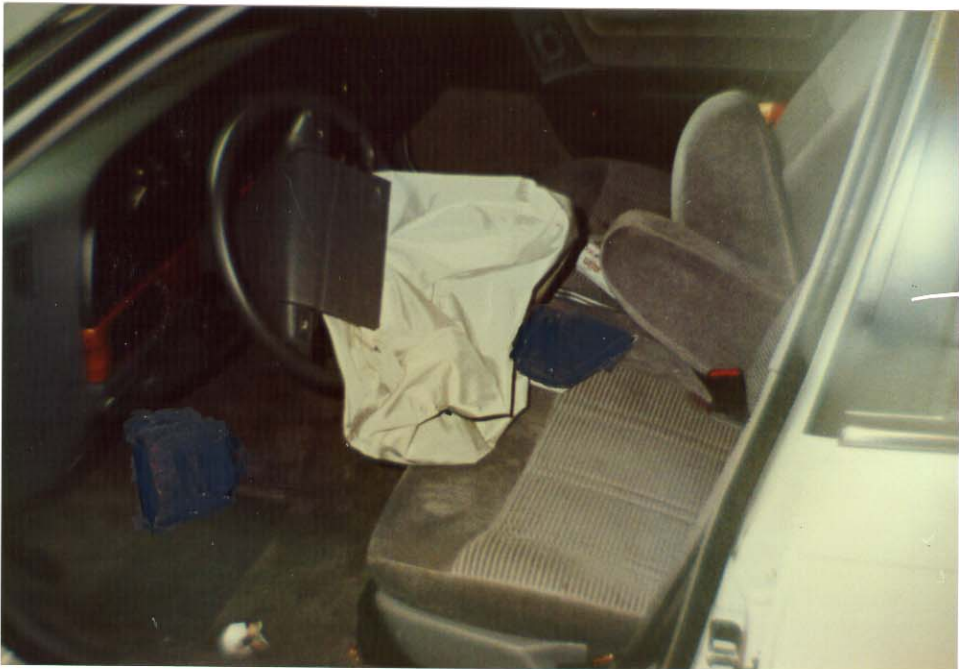
The interior of the Ford Taurus sustained minor damage that was associated solely with occupant contact. The driver's thoracic area loaded the steering assembly through the air bag and deformed the upper steering wheel rim 0.75" forward. Her loading force was transmitted into the steering column which compressed the energy absorbing steering column 1.1". The driver's involvement with the steering assembly fractured and deformed the right cruise control switches that were located between the upper and lower spokes, adjacent to the air bag module. Her knees contacted the steel knee bolster 7-8.25" and 13.9-15.1" left of center. Although no residual damage occurred to the bolster, scuff marks identified the contact areas. The driver's left facial area impacted the mid left A-pillar. Again, no residual damage occurred to the pillar; however, tissue transfers evidenced the contact area. Blood stains were noted to the face of the deployed air bag and on the active belt webbing in the area of the latchplate.

Overall Interior View And Of The Deployed Air Bag And Upper Module Cover Flap.

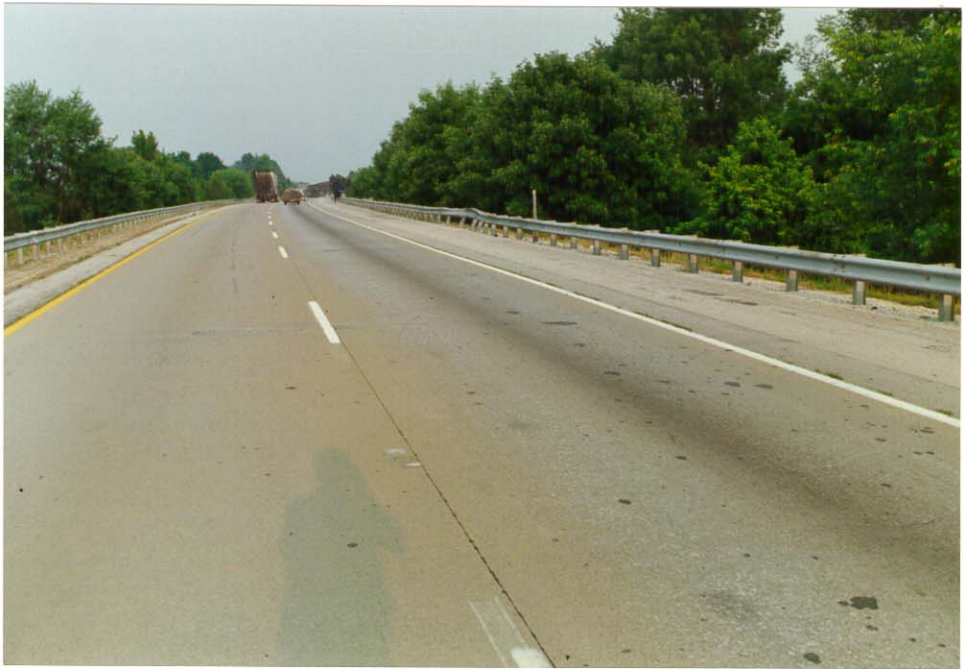
Pre-Crash Trajectory Of The Ford Taurus.

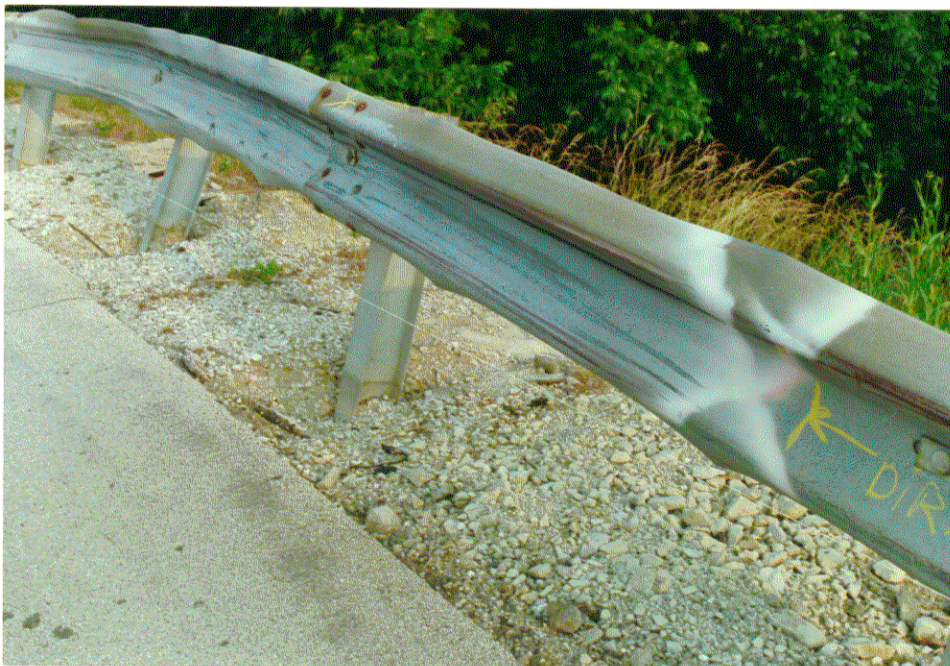
The frontal area of the Ford Taurus directly contacted 23'9" of the W-beam guardrail system. The force of the impact deformed 59'5" of the guardrail to a maximum depth of 28.5" and displaced six guardrail posts. Post displacement ranged from 1-14" of movement. Within the area of the deformed guardrail, red paint transfers were visible on the W-beam and red plastic debris was found in the area, indicating that this section of guardrail had sustained an impact prior to this crash. The extent of damage to the guardrail system from the previous impact was unknown.

Beginning Of Direct Contact Damage on Guardrail,
Also Note Unrelated Red Paint Transfers.

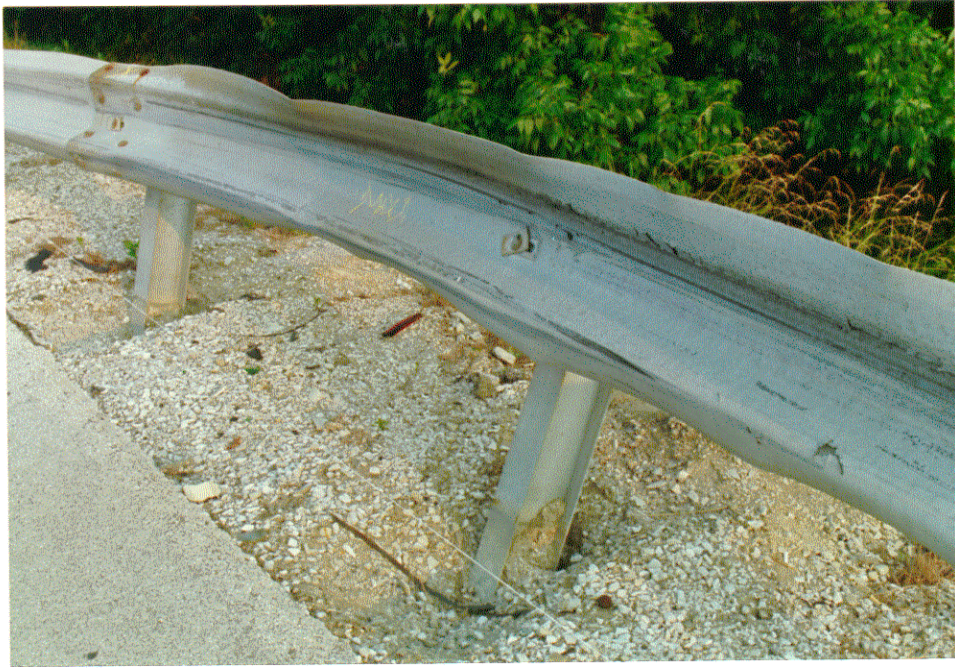
Maximum Displacement of Guardrail.

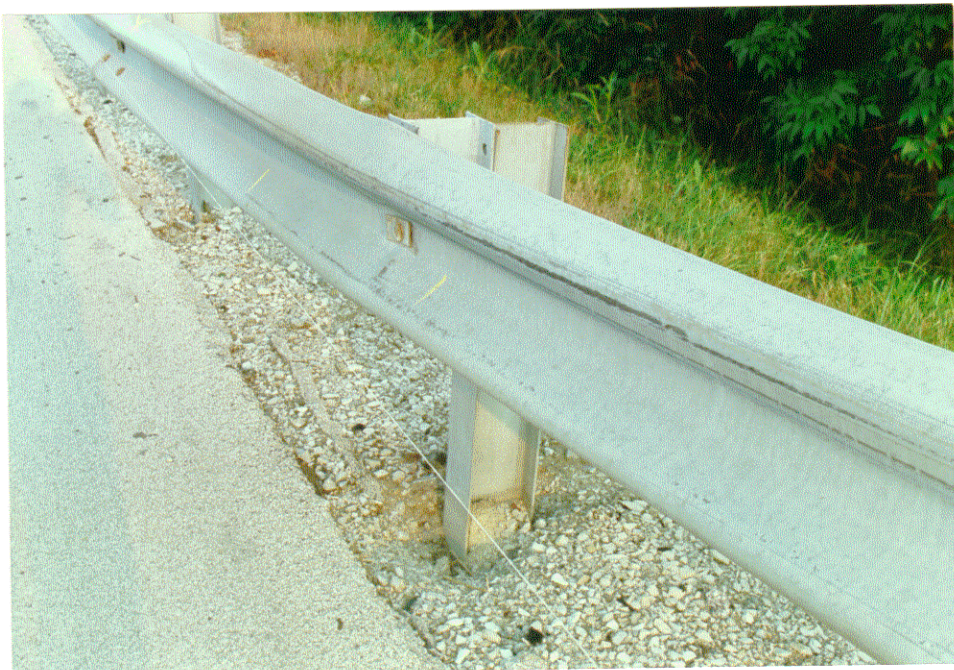
End of Direct Contact Damage.

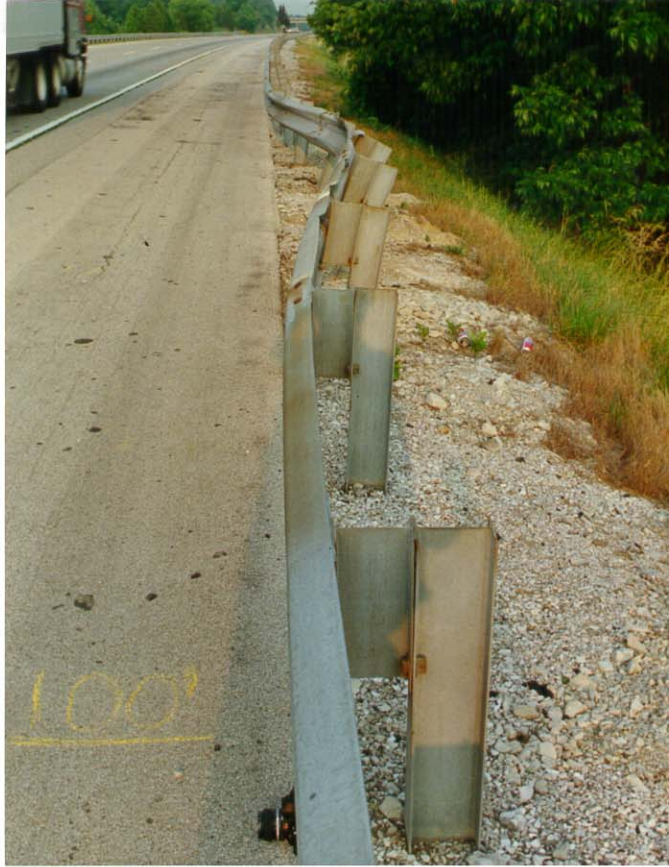
Longitudinal View Showing The Extent Of Guardrail Displacement.

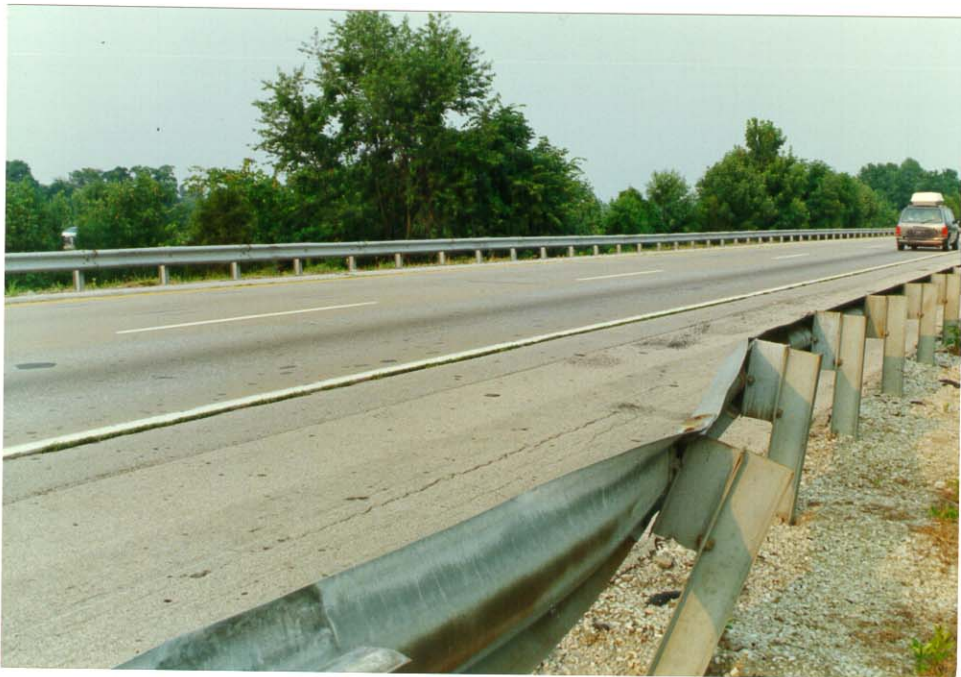
Vehicle Separates From Guardrail And Crosses Travel Lanes
Rotating In A CCW Direction.

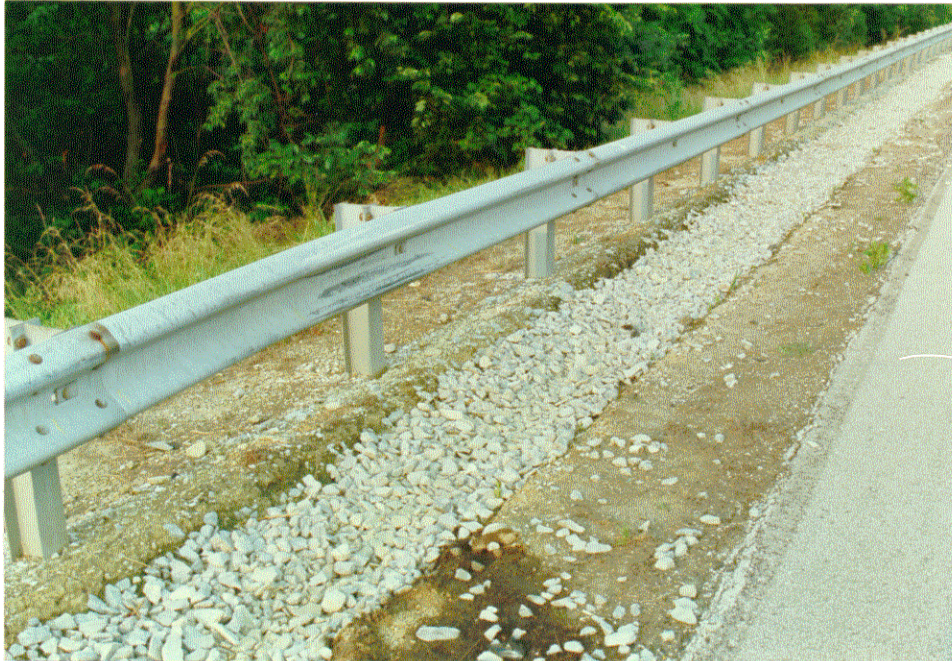
Secondary Guardrail Impact Damage.

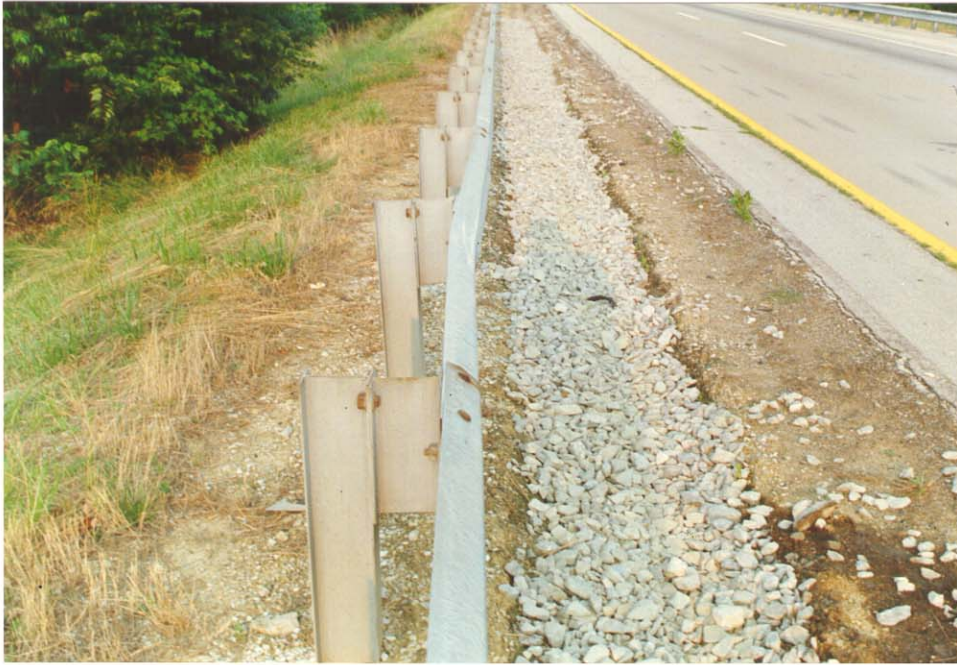
Longitudinal View Of The Guardrail Damage.

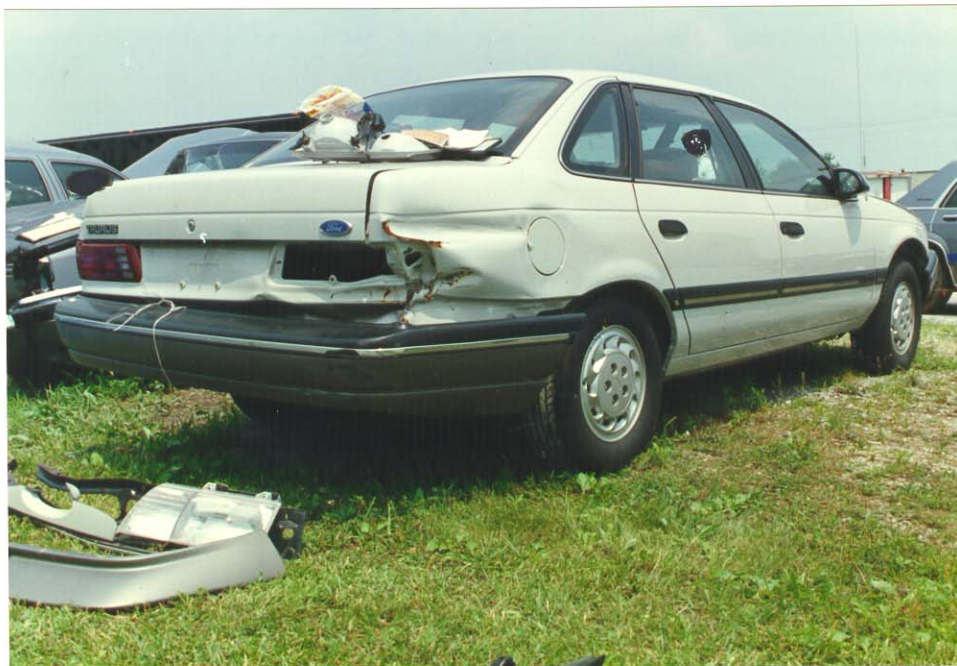
Secondary Guardrail Impact Damage To The Right Rear Area.

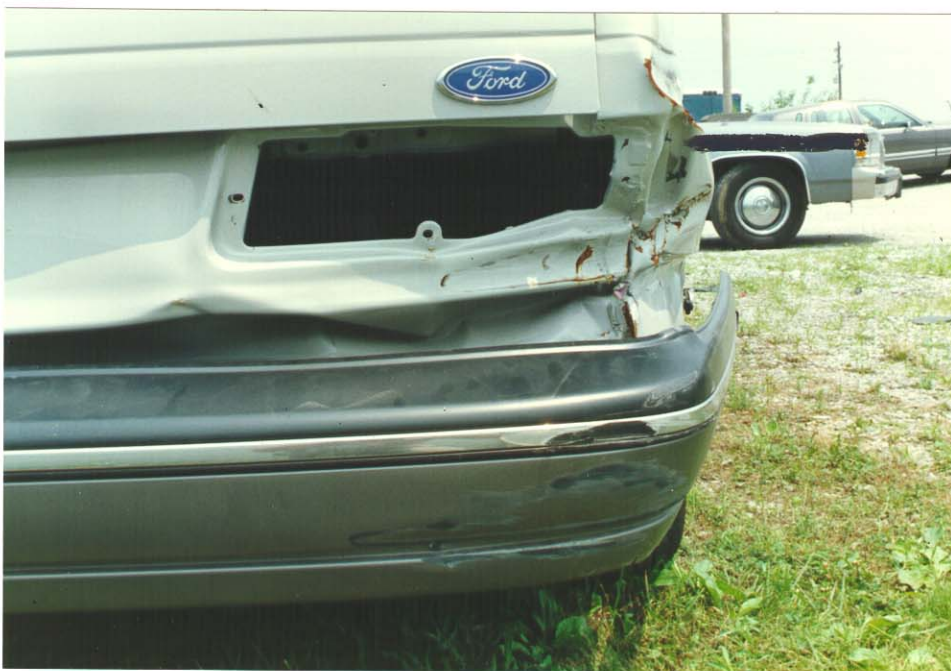
Direct Contact Damage Across The Right Rear Bumper Area.

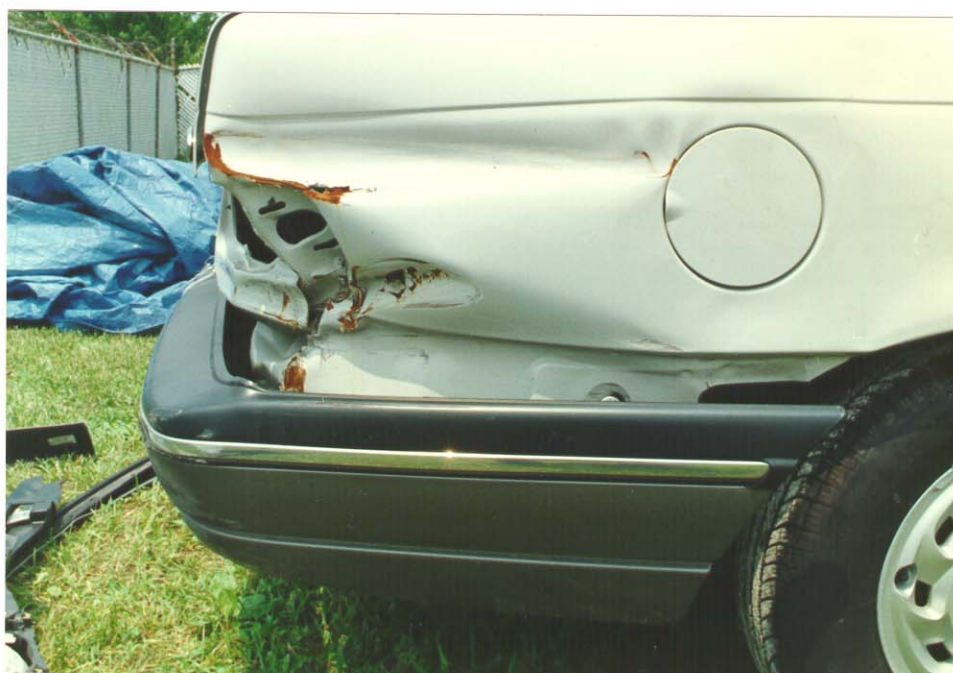
The right rear quarter panel area of the vehicle engaged with the guardrail as the vehicle continued in a rearward direction before coming to rest. Direct contact damage began at the corner area of the sheetmetal and extended forward 23.125", ending 16.75" rearward of the right rear axle position.

Damage That Extended Onto The Right Quarter Panel.

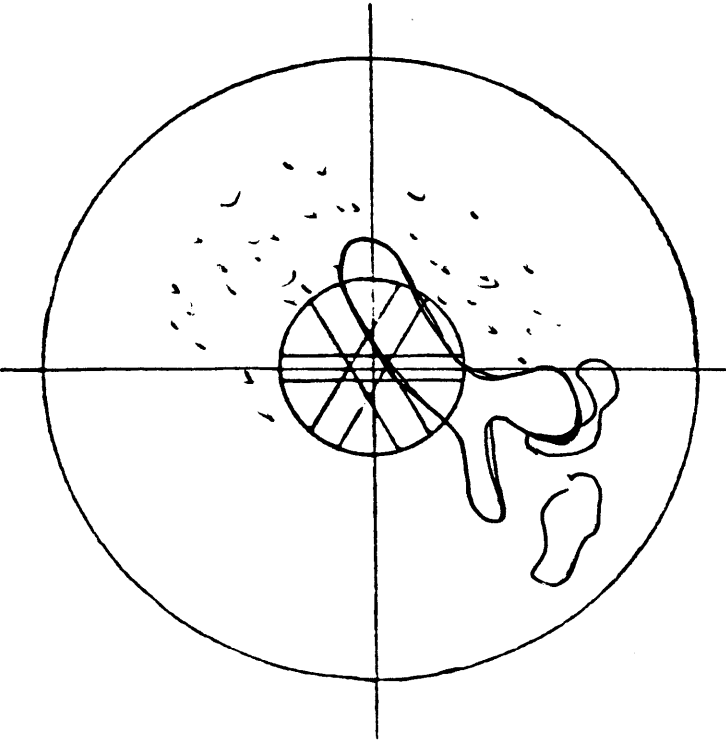
BLOOD STAIN ON AIR BAG
